# Fairview-Pointe-Claire REM station: An assessment of safety and access conditions

The Fairview-Pointe-Claire REM station, opened in May 2026, is a light rail transit station in the West Island of Montreal. The station is directly connected to a bus terminal serving several STM bus routes. To assess how the station's design and surrounding infrastructure influence passenger behaviour, videos of the area at various times of day are recorded and analyzed. The observations reveal several instances of unsafe behaviour that appear to be influenced by the station's design.

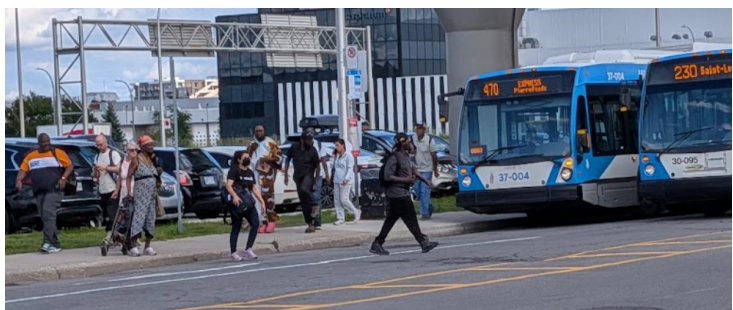
Figures 2 and 3: Bus passengers crossing mid-block

- Two STM bus stops are currently located across of Fairview Avenue from the station, forcing passengers to cross the street when transferring to or from the REM.
- Despite a pedestrian crosswalk nearby, the location of the bus stops leads to observed mid-block crossings by passengers. In an observed cycle (105s), 8 out of 19 pedestrians crossed mid-block.
- A sidewalk that abruptly ends near the southwest corner of Fairview Avenue falsely indicates a path for passengers crossing towards the bus stops.

- » **Move all streetside bus stops into the bus terminal** to reduce mid-block crossings of Fairview Avenue and to improve the waiting experience.
- » **Convert the current paratransit and employee parking area into a general passenger drop-off area with clear signage.** Employee and bus driver parking should be relocated.
- » **Update pedestrian signal timing at the intersection to reduce cycle length and minimize pedestrian waiting times.** This should reduce the incentive to cross during the vehicle phase, to de-incentivize illegal pedestrian crossings.
- » **Extend the existing bike lane on Fairview Avenue** to connect the REM station and bus terminal to existing cycling networks.

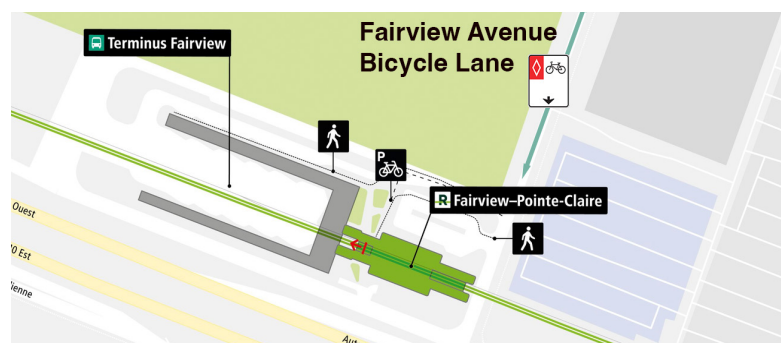
Figure 6: Current cycling access configuration

- The bicycle lane on Fairview Avenue abruptly ends just north of the station without access to a cycling network (Figure 7). Moreover, the southbound cycling lane is shared by cyclists and buses and is in poor condition, with potholes crowding the entire cyclable width at certain locations.
